La zona de alta intensidad es la señal de color blanco brillante en la parte posterior del [anillo fibroso](#) en imágenes de RM en T2.

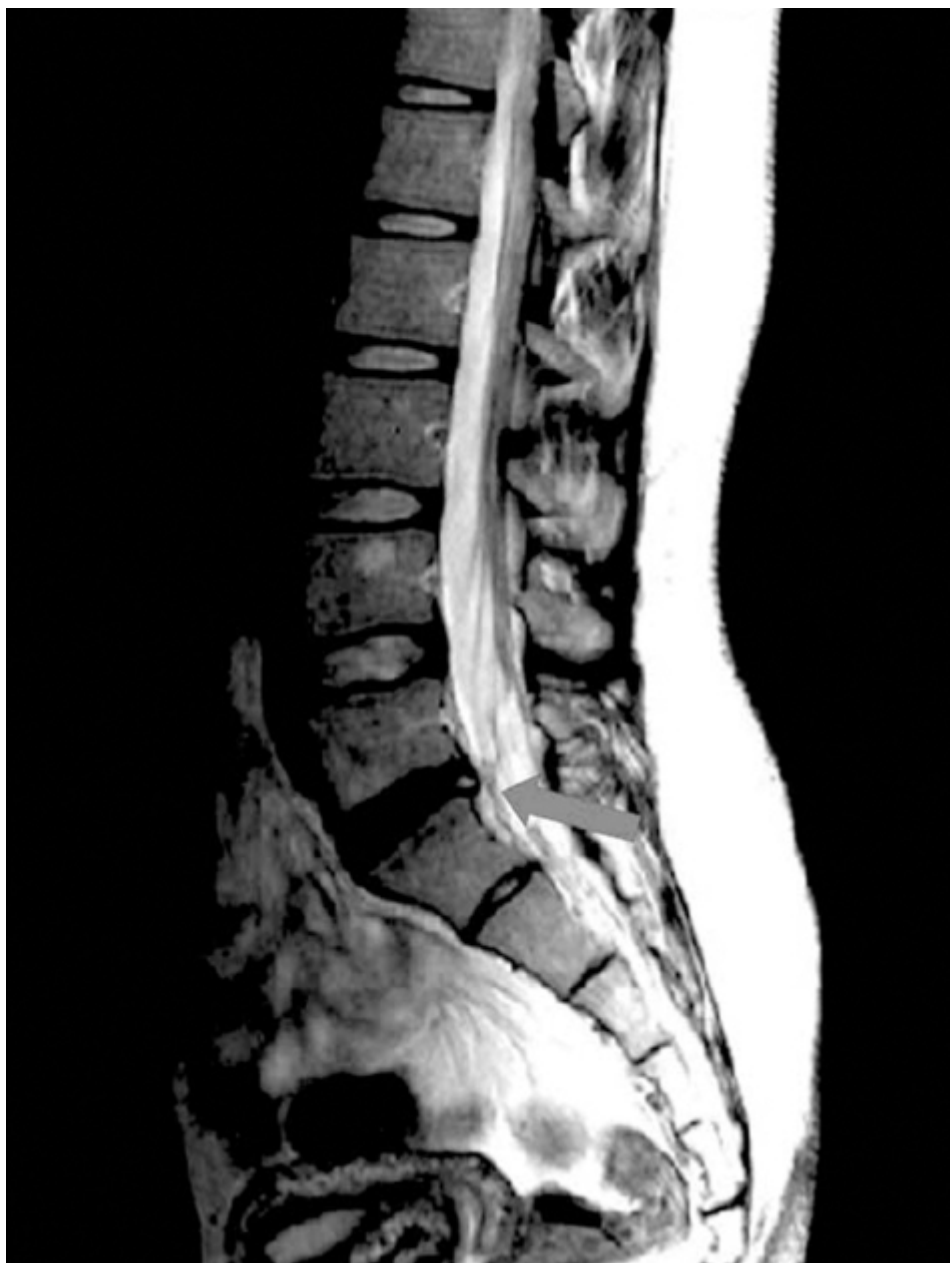
Se piensa que es un desgarro radial en el espacio anular posterior del disco.

Los pacientes con dolor lumbar asociado a ciatalgia, con más de cuatro episodios de exacerbaciones previas de dolor lumbar y la presencia de una zona de alta intensidad en la RM tienen una mayor tasa de discografía positiva, aunque estos resultados no son estadísticamente significativos (López y col., 2012).
